AN ANALYSIS OF THE EVIDENCE CONTAINED IN RHODESIAN REPORT'S
ANNEXES II AND III AND THE UN GENERAL ASSEMBLY REPORT A/5069 PERTAINING
TO THE CRASH OF DOUGLAS DC-6B SE-BDY S/N 43559 ON SEPTEMBER 17-18, 1961

By Joseph Majerle III

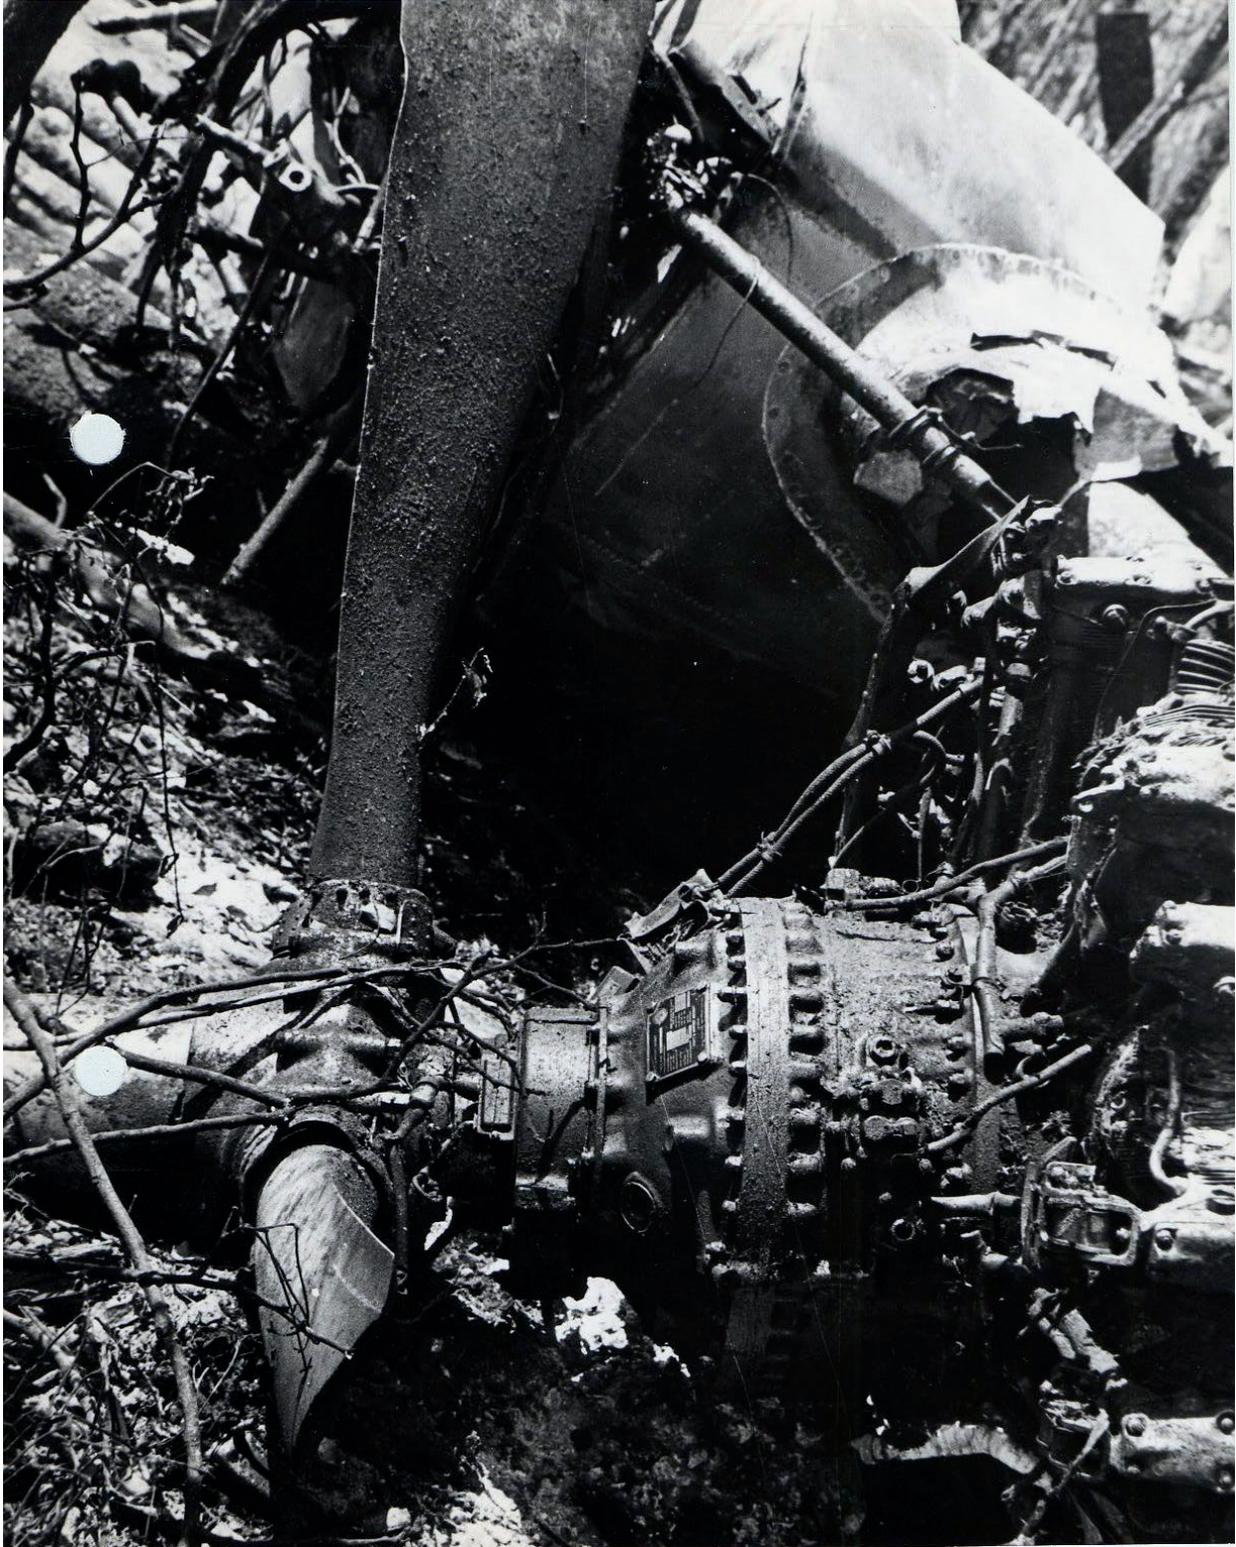
1: #1Engine/Propeller. (# S-0727-0004-01-00041 UN website file.)

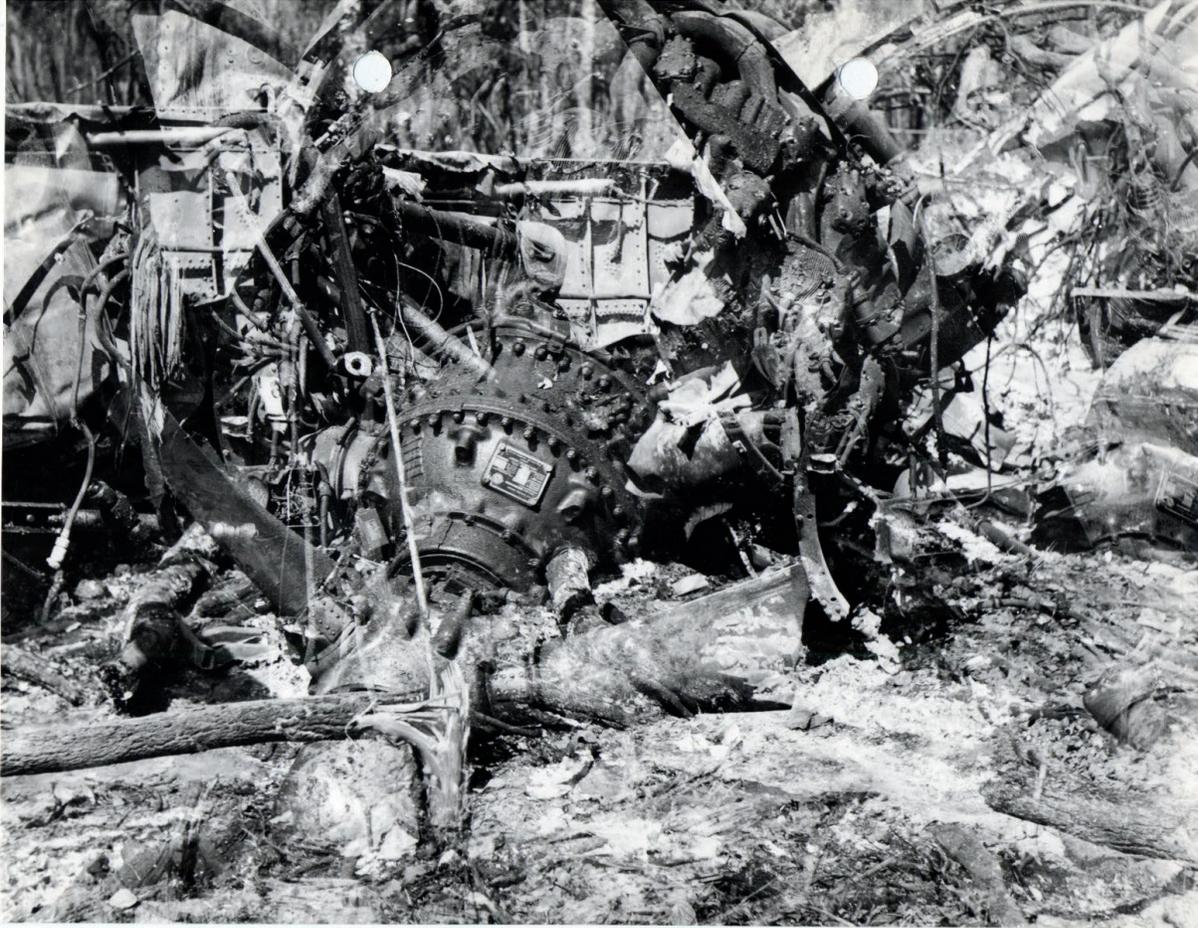
2: #2 Engine/Propeller. (# S-0727-0004-01-00021 UN website file.)

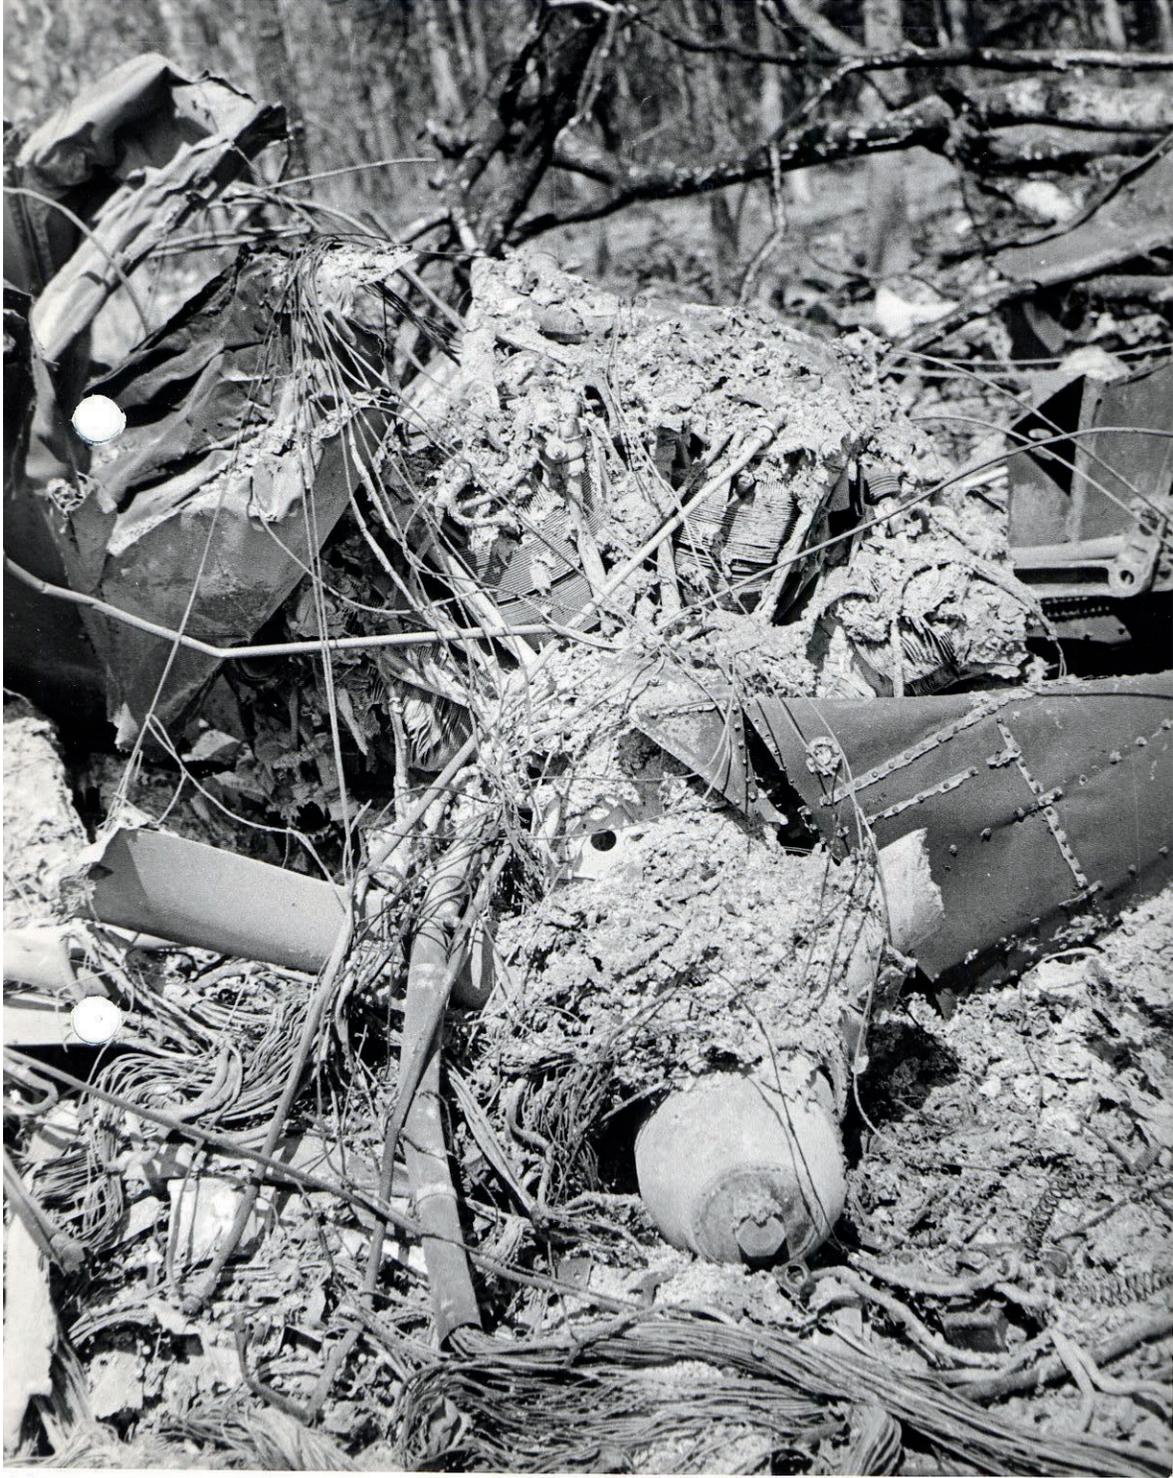
3: #3 Engine/Propeller. (# S-0727-0004-01-00039 UN website file.)

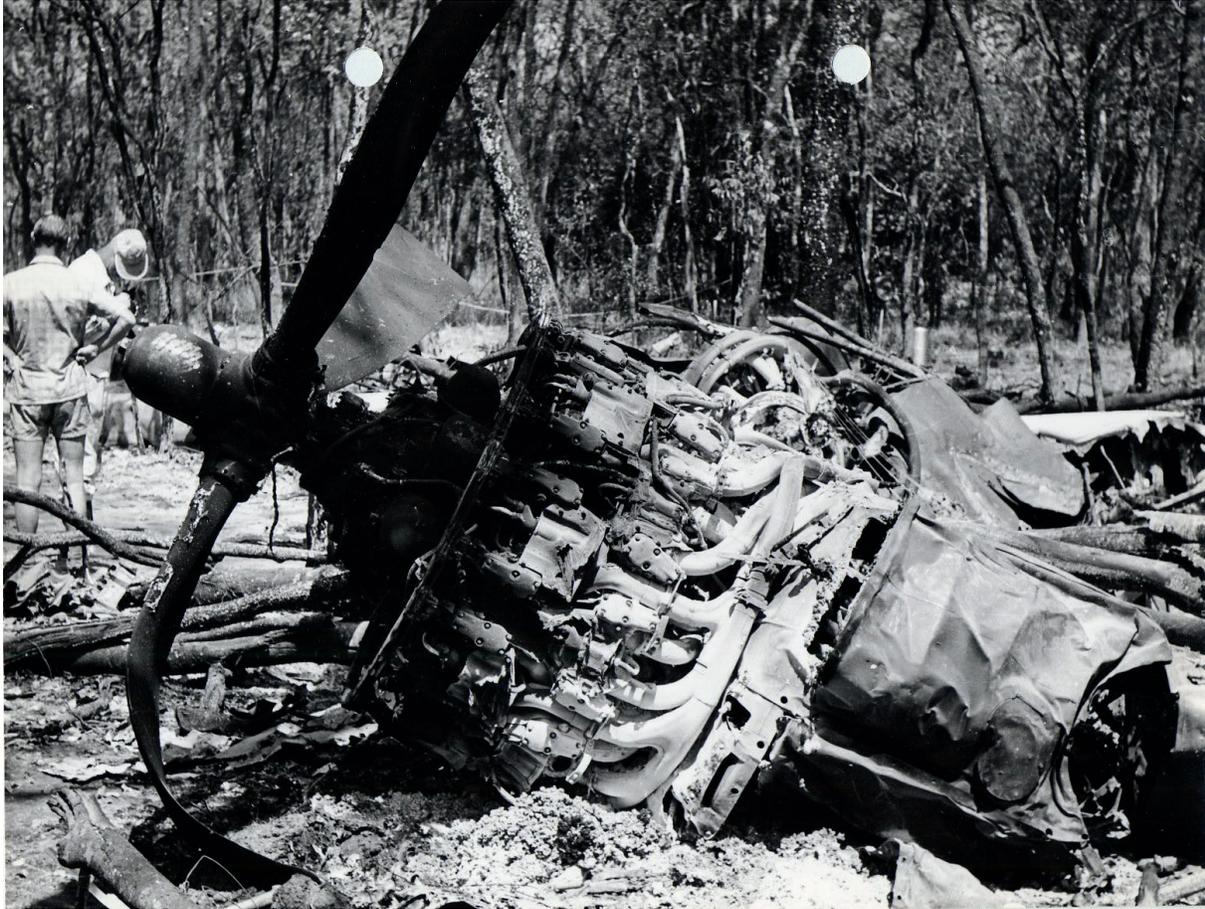
4: #4 Engine/Propeller. (# S-0727-0004-01-00016 UN website file.)

"The damage sustained by the number 4 propeller was considerably less than that sustained by the other three propellers."

On the same subject, the #4 propeller/engine is its own case. All indications throughout are that the right wing rode higher, struck fewer and smaller trees, and relatively speaking, sustained the least damage. The condition of #4 is, again relatively speaking, reflective of the right wing itself. The engine was not developing enough power to break any of the blades, which also didn't penetrate the ground as deeply as all the others. In my view the most likely explanation for this is that the ignition was stopped by grounded primary (p-lead) wiring in the cockpit breakup event. The power section/drivetrain momentum would have kept the propeller rotating throughout the cartwheel sequence and until it hit the ground where it and the nacelle were torn from the wing. Per Mr. Apthorp's report, the #3 propeller blade of #4 engine bore the weight and bent beneath the engine/nacelle until it came to a stop. But as to why it and the #2 blade were reversed if the #1 blade was in fact not reversed is a phenomenon for which I have found no answer. The movement of the rotating cam within the dome assembly actuates all blades equally and simultaneously. Possibly the locating dowels of the fixed cam were sheared by the striking of the #2 & #3 blades prior to the #1 blade's contact, and the #1 just followed wherever the fixed cam stopped. Again, I have no recollection of having heard of that happening but can't rule out its possibility. Another question for the HSP Repairman.

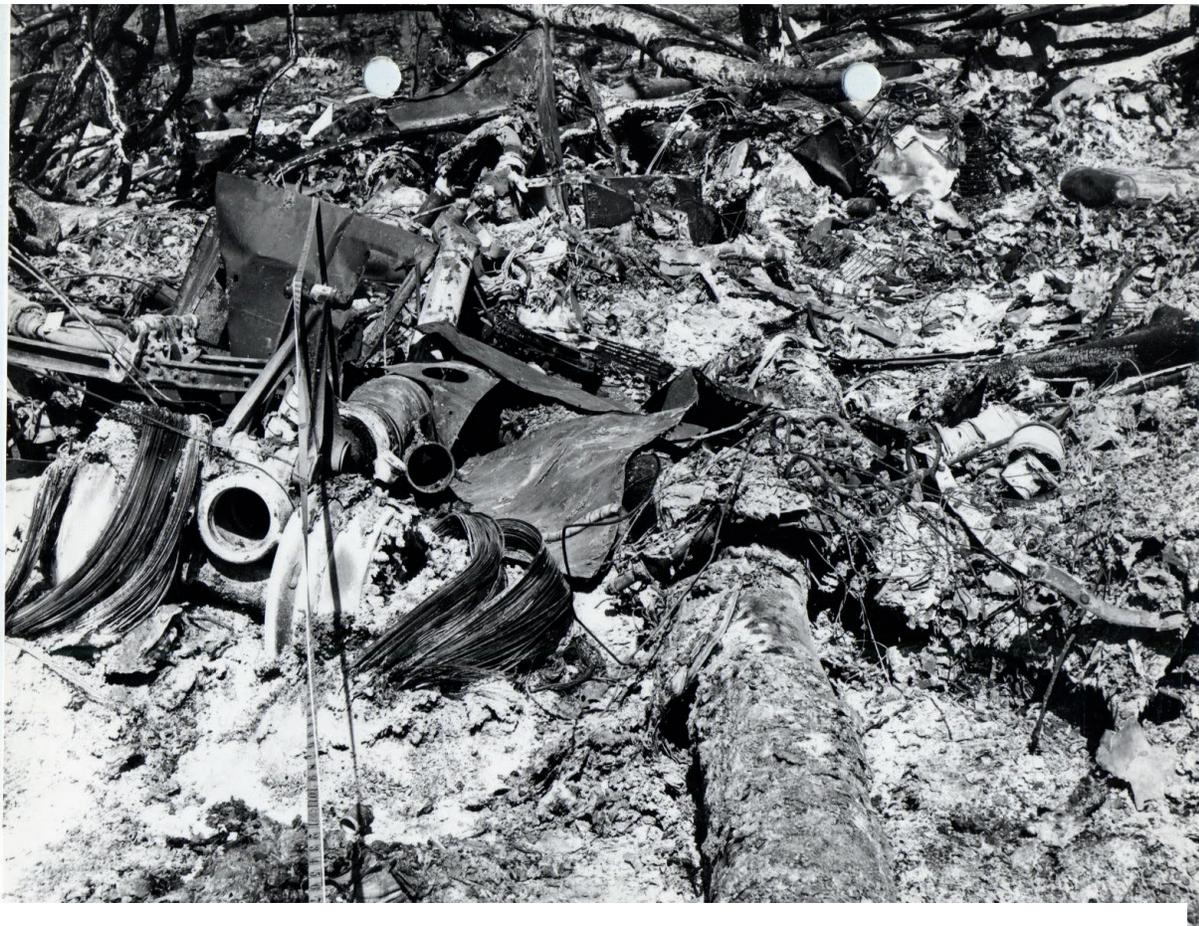
10: The main landing gear with both tires in place. (# S-0727-0004-01-00019 UN website file.)

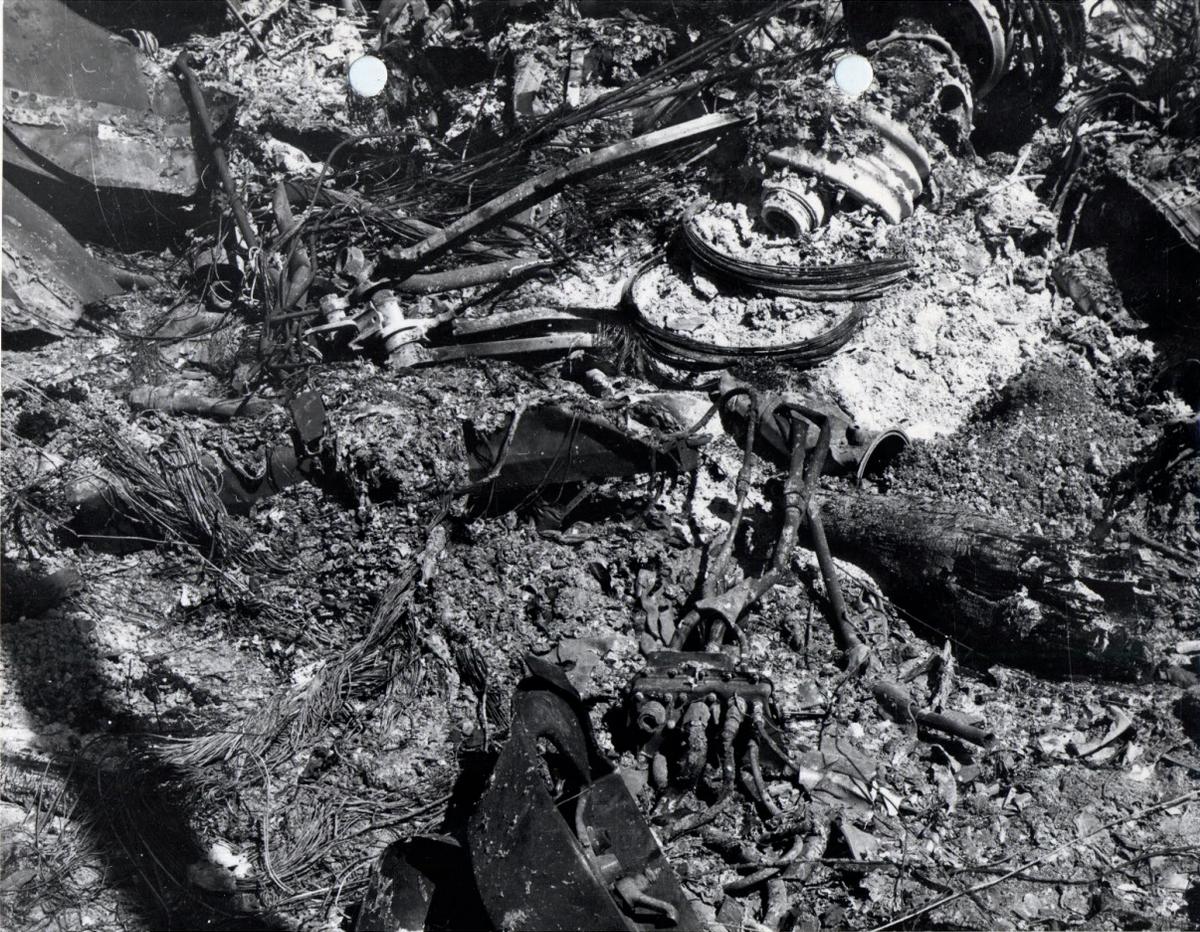
11: Compression-bent retraction links on main landing gear. (# S-0727-0004-01-00018 UN website file.)
