AN ANALYSIS OF THE EVIDENCE CONTAINED IN RHODESIAN REPORT'S
ANNEXES II AND III AND THE UN GENERAL ASSEMBLY REPORT A/5069 PERTAINING
TO THE CRASH OF DOUGLAS DC-6B SE-BDY S/N 43559 ON SEPTEMBER 17-18, 1961

By Joseph Majerle III

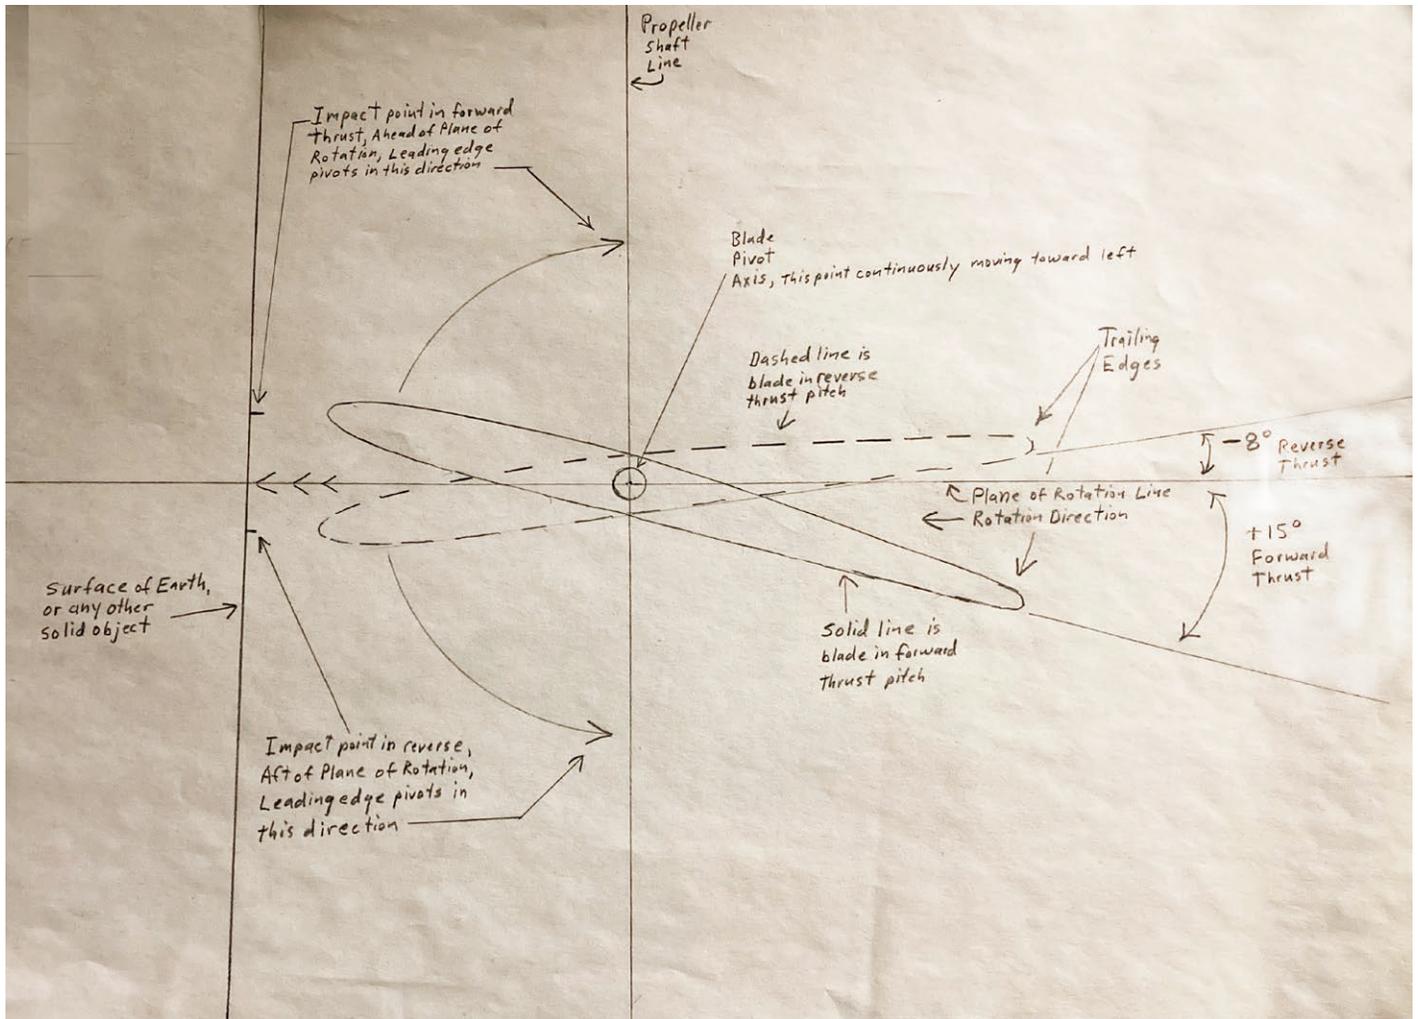
Mr. Apthorp's determination that sheared drive pins and retaining screws constitutes complete dismissal of their blade's actual angle at moment of strike is not borne out in my experience. I have on numerous occasions found sheared drive pins and screws with virtually no discernable rotation of the blade on the bushing, or in some cases very little, and in no cases did the blade then rotate toward reverse. In most cases they had moved toward feather at a positive angle, with the leading edge forward, as is logical when they strike at a positive, forward thrust angle. The following diagram (photo 5) illustrates the basic physics of the result of a blade striking the ground or an object.

5: Blade strike diagram. (Drawing by J. Majerle.)

Note on the drawing that the blade pivot axis /propeller shaft line is not centered on the blade chord line; it is universally somewhat closer to the leading edge than the trailing edge on modern propeller blades. And by modern, I mean since before World War I, before even the invention of the variable-pitch propeller. While the fact that there is more surface area aft of its pivot axis contributes in some measure toward its tendency for the leading edge to twist forward (positive angle) if contacted on its camber (front) face, the strike angle of the leading edge forward of its pivot axis is the primary factor determining the direction that a propeller blade will stop at when rotating under engine power.

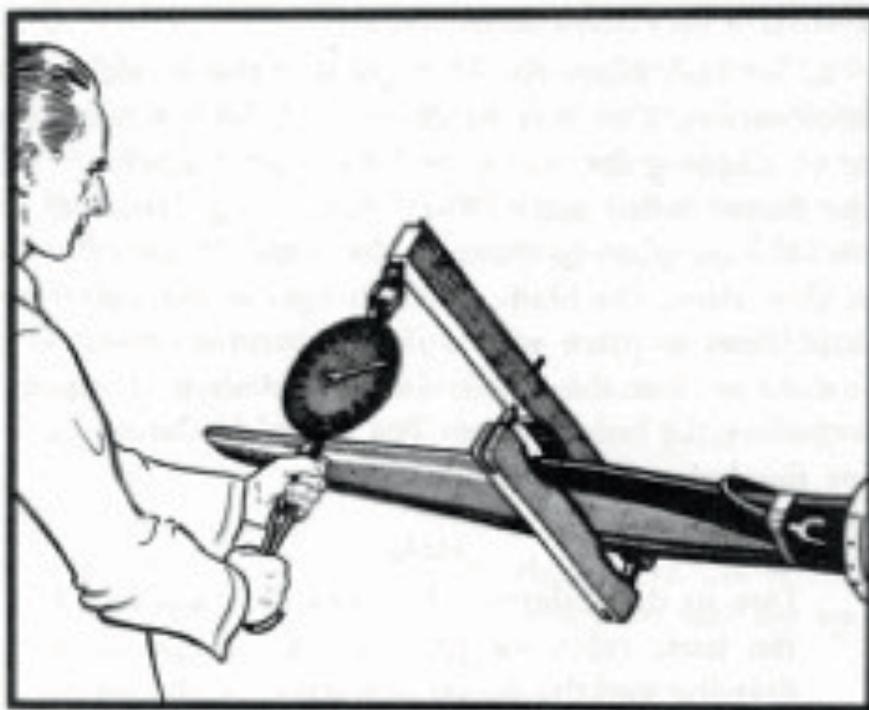
Per Hamilton Standard Propeller Overhaul Manual 163B, par. 2-159, the required blade pre-load is 100 plus or minus 10 lbs., break-away torque. This means that a force of optimally 100 lbs. is required 12" away from the center pivot line, just to begin to twist the blade on its center bushing surface and its roller bearings. This is without the resistance of the pitch-change system contained within the hub. For another perspective, this is the same force required to properly tighten or loosen the wheel bolts on my Volvo car. Figure 2-128 below (6), the man in the illustration is pulling down 45 to 55 lbs. on the spring scale with a 24" bar, just to get the blade to move.

6: Blade torque check. (Figure 2-128 of Hydromatic Reversing Propellers, Overhaul Manual.)

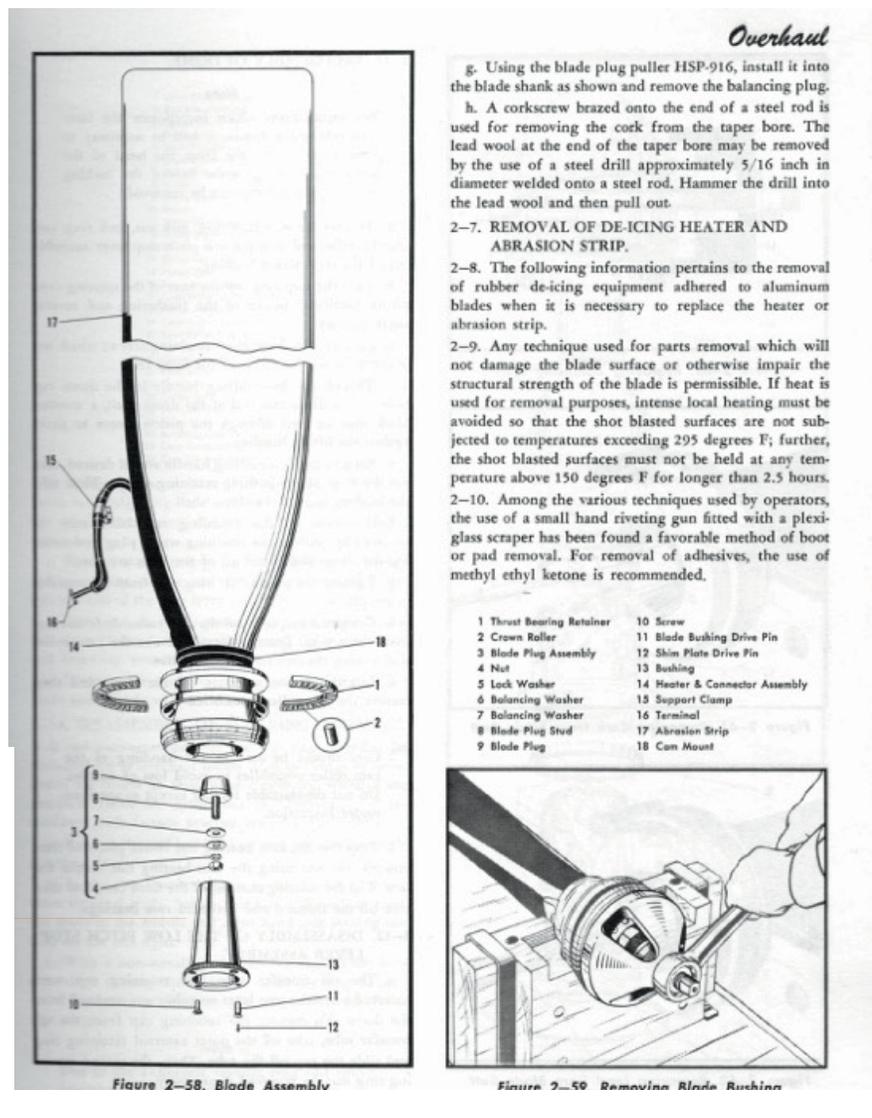
Another factor not explained in Mr. Apthorp's conclusion is the friction of the taper interference fit of the blade bushing to the blade shank bore, which is the primary attachment of the bushing to the blade. The drive pins are primarily an indexing device to assure uniformity of blade angle to the blade gear segment, and the retaining screws are mainly to assure that the parts stay together while being assembled. A single 5/16" or 3/8" steel pin and the same for a single steel screw, is not the primary power transfer system for 2500 horsepower to be transmitted through three blades. In other words, without the screws and pins the blades don't just roll around freely on the bushings. Fig. 2-59 below (7) gives an idea of the force required to loosen and remove the bushing from the blade shank bore.

These teeth on the blade bushing (item 13) mesh with the teeth on the blade gear segment (fig. 2-57 below.)

7: Left - Blade Assembly (Figure 2-58) and right - Removing Blade Bushing (Figure 2-59, both from Hydromatic Reversing Propellers, Overhaul Manual.)

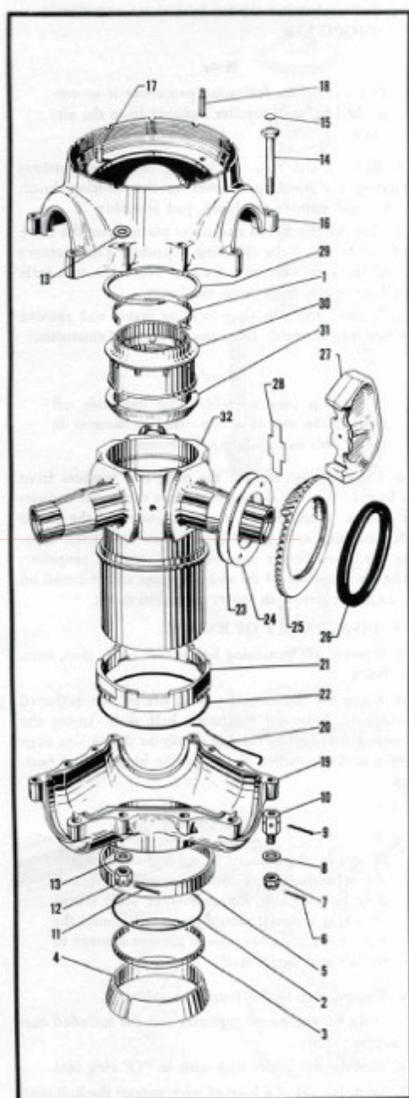
Figure 2-57. Barrel Assembly

Yet another factor not explained in Mr. Apthorp's conclusion is the findings of the blade gear segment/blade bushing serrated drive teeth interface, of the two propellers that he did manage to disassemble to that stage. As can be seen in figure 2-57 below (8) and figure 2-58, above (7), the very finely cut teeth on the inside diameter of the blade gear segment (item 25), made from hard tempered steel, and the outside diameter of the blade bushing flange, made from brass (item 13) mesh together, allowing for a very finely adjustable angular relationship between the blade gear segment and the blade bushing. For propellers #1 & #4 Mr. Apthorp claims that "all blade gear segments were fitted with index angle 29 deg. in line with "A" reference line on blade center bushings". Which, according to the HSP manual, is the correct index angle for the +96 to -8 spec. for the DC-6 series installation. His statement would indicate that the steel/brass interface remained intact.

These teeth on the blade gear segment (item 25) mesh with teeth on the blade bushing (fig. 2-58 above).

8: Barrel Assembly. Note #25 showing the Blade Gear Segment. (Figure 2-57 of Hydromatic Reversing Propellers, Overhaul Manual.)

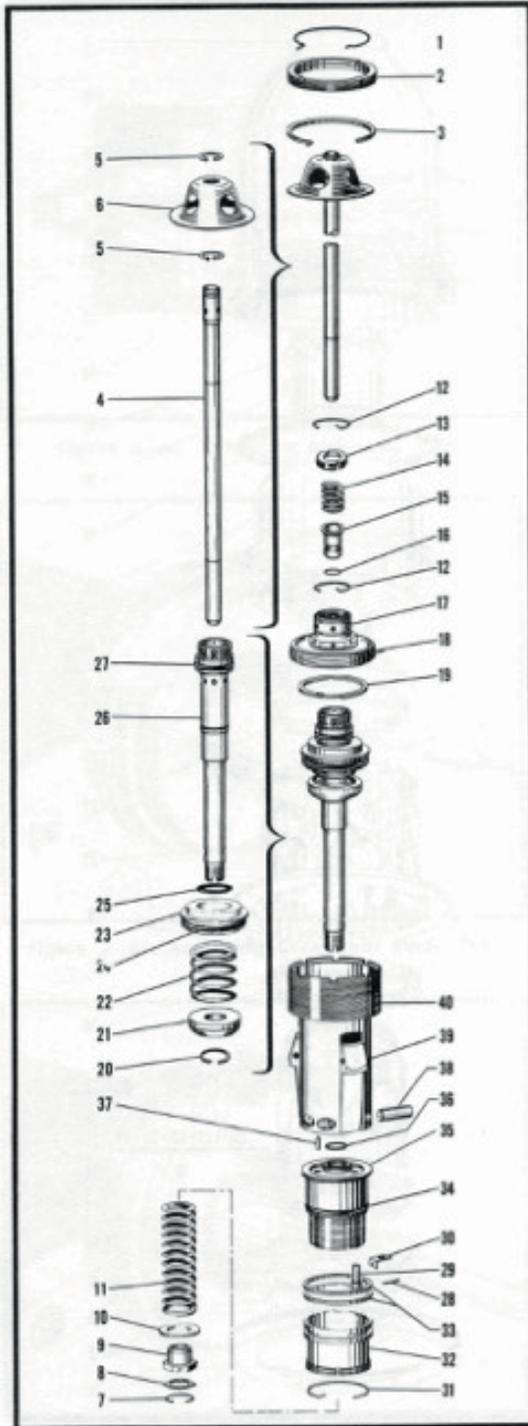
Figure 2-64. Low Pitch Stop Lever Assembly

There is one other possible explanation for the alleged finding of the cam rollers in the constant speed (positive angle, forward thrust) slots of the fixed cam, and that is the stop return spring, in combination with the other two springs in the low pitch stop lever assembly, figure 2-64 below (9). However improbable in my mind, I cannot say that the springs in combination with the fact that the oil in the dome/piston chambers being super-heated by the external fire couldn't have returned the low pitch stop levers to the stops. It would have required overcoming the friction of the displaced blade gear segments/blade bushings, on all four propellers, but again I don't know if that would be impossible. I do, however, think it unlikely. That is a question, among all of these, for an experienced, reversing-qualified HSP Repairman.
